LANDSLIDES ON MOUNT TREBEVIĆ SLOPES – ANALYSIS OF THE RESEARCH RESULTS

Mevlida Operta, Boris Avdić, Edin Hrelja

The study area is located on the northwestern slopes of Mount Trebević, in a densely populated area. Based on previous research at slope parts of Trebević, three complex with large-scale landslides wereidentified (landslide of Hambina Carina, landslide of Mrakuša and Trebevićka Street landslide-expanding complex) and there were observed also landslides of Soukbunar and Jewish cemetery. By the research conducted during 2014, drilling of exploratory wells was carried out, as well as engineering-geological and geotechnical investigations and laboratory testing of samples of soil and rocks that are a continuation of earlier started researches. By the research, there has been collected enough data to create a study on engineering-geological and geotechnical characteristics of the terrain and for the purposes of the regulatory plan (RP) "Soukbunar". After realization of the planned work, it was approached to drawing up of elaborate and database for objects.

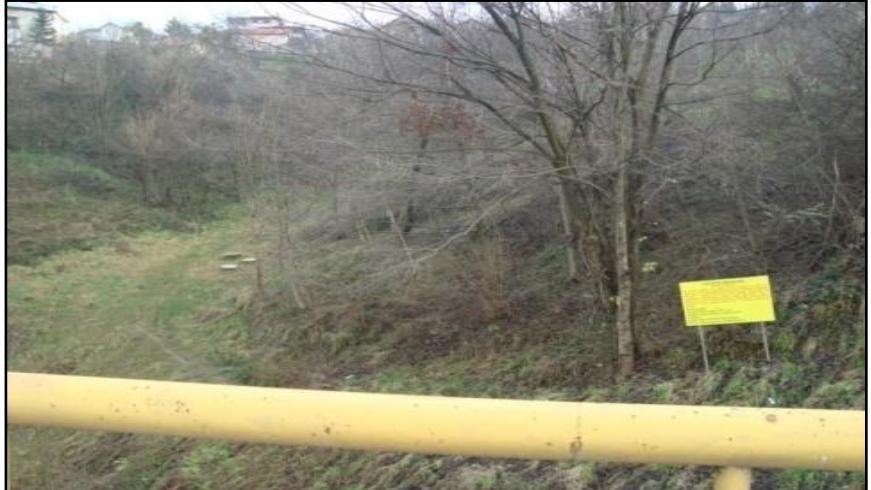
Figure 2: Drainage system and caution board about active landslide in the lower part of Mrakuša locality

Landslide "Mrakuša" is a continuation of the landslide "Hambina Carina" area of 15.5 hectares. Allocated were five prominent i.e. large private sliding units (HP-1 HP-5), and with them, seven individual small sliding bodies. Landslide is of complex type and now it is mitigated (Figure 2).

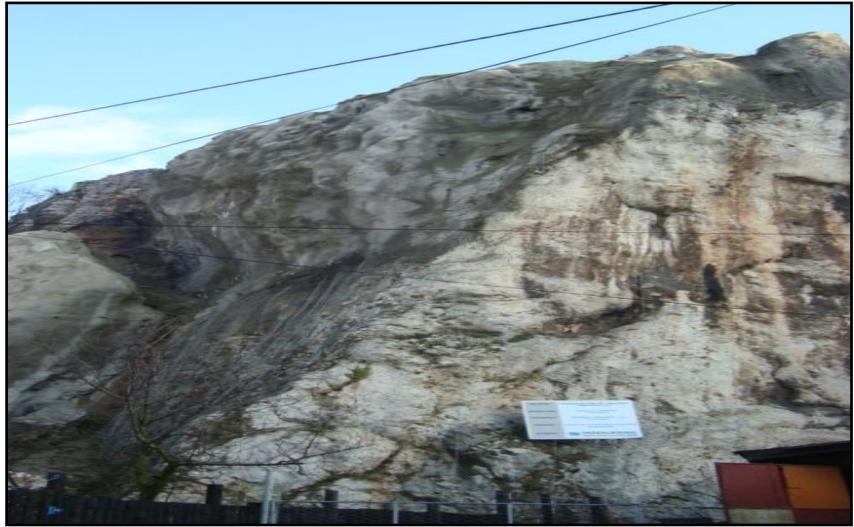
Figure 3: Mitigated escarpment and caution board in the Trebevićka Street

Landslide on the upper side of the Trebevićka street (landslide KT-1) where the partial mitigation was on, because when stopping motion directly above the road, that certainly could contribute to the stability of the lower parts of the slopes and buildings.

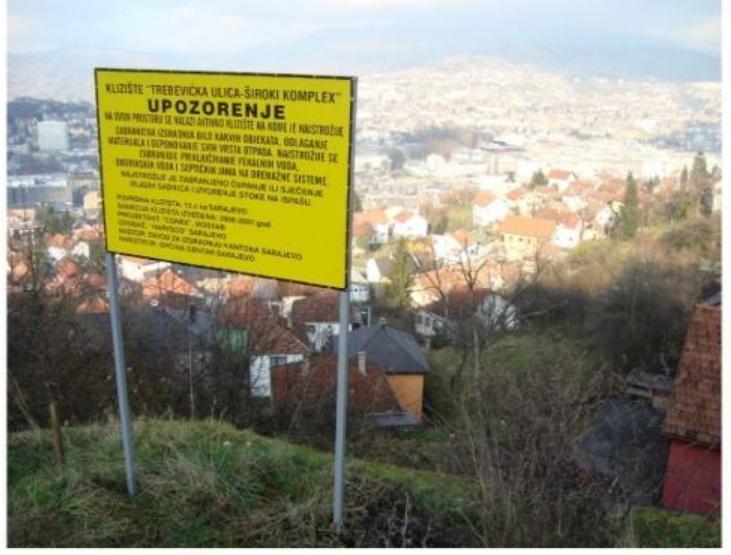
Figure 4: Caution board about active landslide in Trebevićka Street – wider complex

Landslide "Trebevićka Street – wider complex" where the performance of remedial measures and work were done in four basic phases.

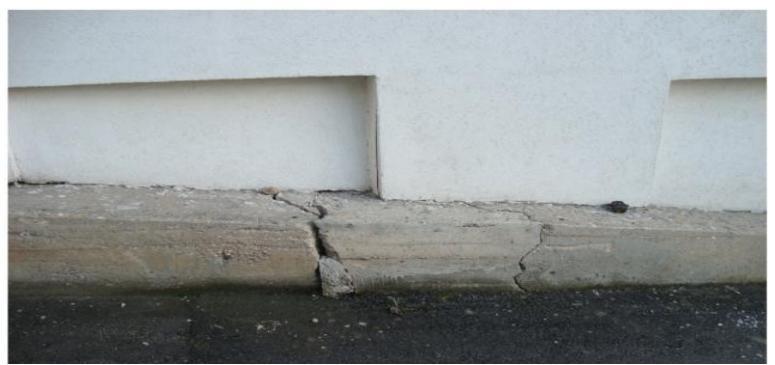
Figure 5: Wall cracks in the streets of Porodica Foht and Soukbunar (Soukbunar landslide)

Landslide ''Soukbunar'' is located directly along the right (east) side of the Trebevićka Street - wider complex landslide. Performing remedial measures and work on the landslide is mainly related to the mitigation and construction of water and sewage network, and with a small part, to the construction of retaining structures.

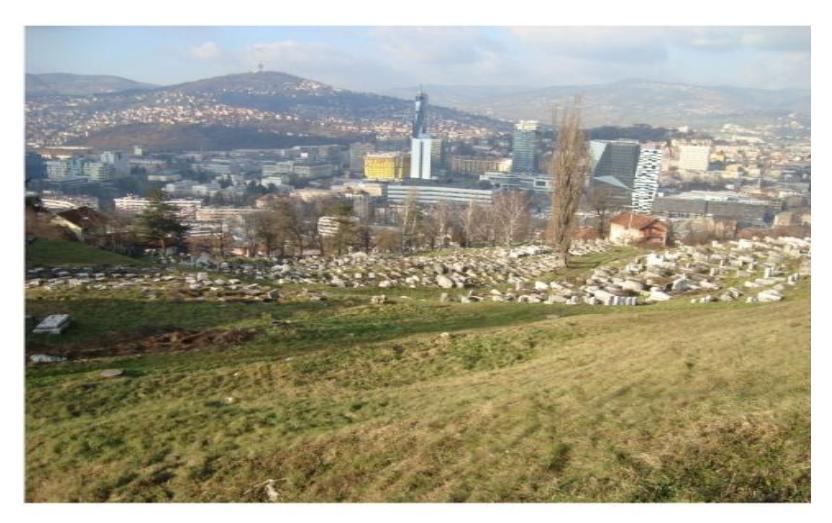
Figure 6: Jewish cemetery landslide

Landslide ''Jewish cemetery'' is located in the area of Jewish cemetery. The mitigation of the landslide was carried out by building of the drainage system and concrete channels for surface drainage.

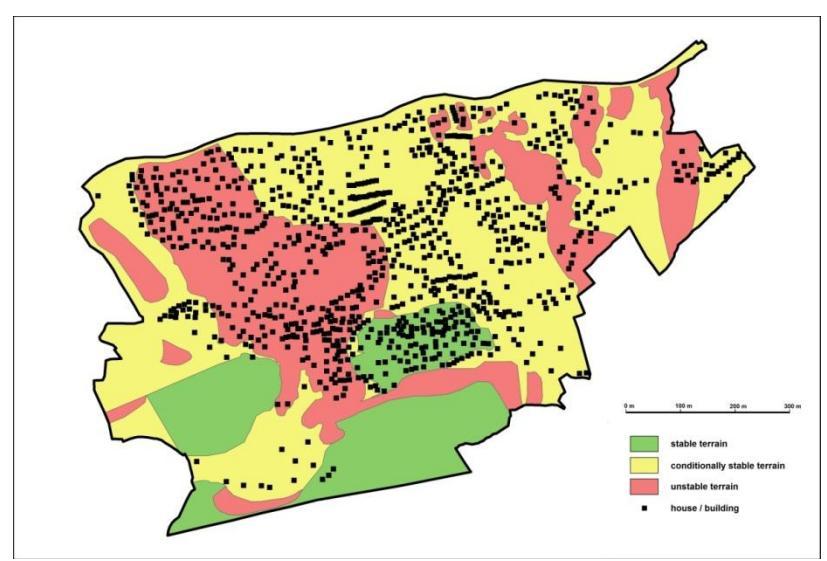
Figure 7: Terrain stability map of Soukbunar

Based on engineering geological mapping and the results of exploratory wells and laboratory testing, terrain's categorization has been performed according to degree of stability: a stable, relatively stable and unstable terrain (Figure 7).

Stable terrain is part of the terrain built of rock substrate masses presented with Anisian limestones. Stable parts of the terrain occupy an area of 14.55 ha, or 17.32% of the study area.

Conditionally stable terrain are part of the hillsides made of embankment materials, colluvial and elluvial-delluvial cover that are, in natural conditions, of stable weight, but in terms of cuts and additional burden can become unstable. Conditionally stable parts of the terrain occupy the largest surface of 42.54 ha, or 50.47% of the study area.

Unstable terrain are courts with active landslides, avalanches and rock creeps. Unstable parts of the field covers an area of 27.14 ha, or 32.21% of the study area. The categorization of the terrain according to construction suitability, in addition to geological structure, the slope of the terrain, hydrogeological and geotechnical properties, and field seismicity, represents a summary assessment, and evenly important are climatic conditions, economic, social, traffic and other factors. Together they form the basis for reaching the final assessment on the benefits for the existing settlements expansion. Standard categorization of the terrain according to construction; courts are favorable for construction; courts conditionally favorable for construction; courts unfavorable for building and grounds extremely unfavorable for construction.

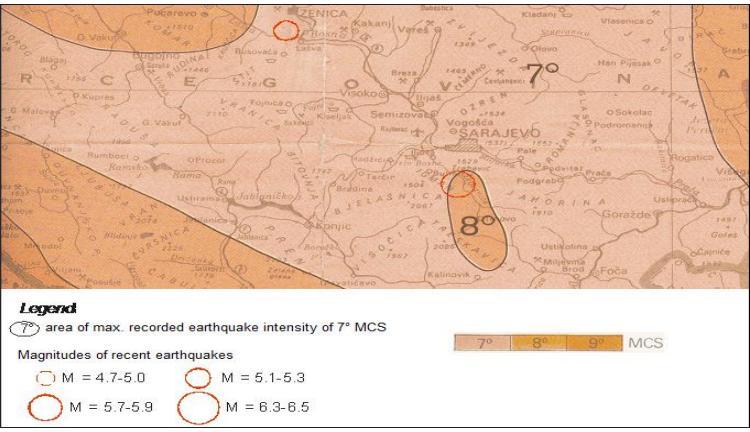
Figure 8: Seismological map for the period of last 500 years

According to manifestations of seismic events and epicentral zones, area Treskavica-Sarajevo is divided into two unstable areas. First is the area north of Kalinovik in domain of mountain Treskavica an area of 124 km² with the intensity of VII° MCS. Eight earthquakes in total were registered, of which one in 1962, with the intensity VIII° MCS, was strongly felt in the city of Sarajevo. The second area is located along the axis of Trnovo-Sarajevo-Vogošća. Part of the area became part of the Sarajevo-Zenica Basin. Stirs up with its own earthquakes with epicenters near Sarajevo, where so far were registered at least 32 earthquakes, and earthquakes from unstable Treskavica zone. The frequency of earthquakes is one at 25-50 years, the intensity of about VII° MCS. The enclosed map clearly shows that the basic level of seismicity of Sarajevo and the subject investigated terrain is 7° MCS.
